**Residual Strength and Repair of Damaged and Deteriorated  
Offshore Structures**

**REPAIR OF DENTED TUBULAR COLUMNS -  
WHOLE COLUMN APPROACH**

By  
J.M. Ricles  
W.M. Bruin  
T.K. Sooi

ATLSS Report No. 97-13

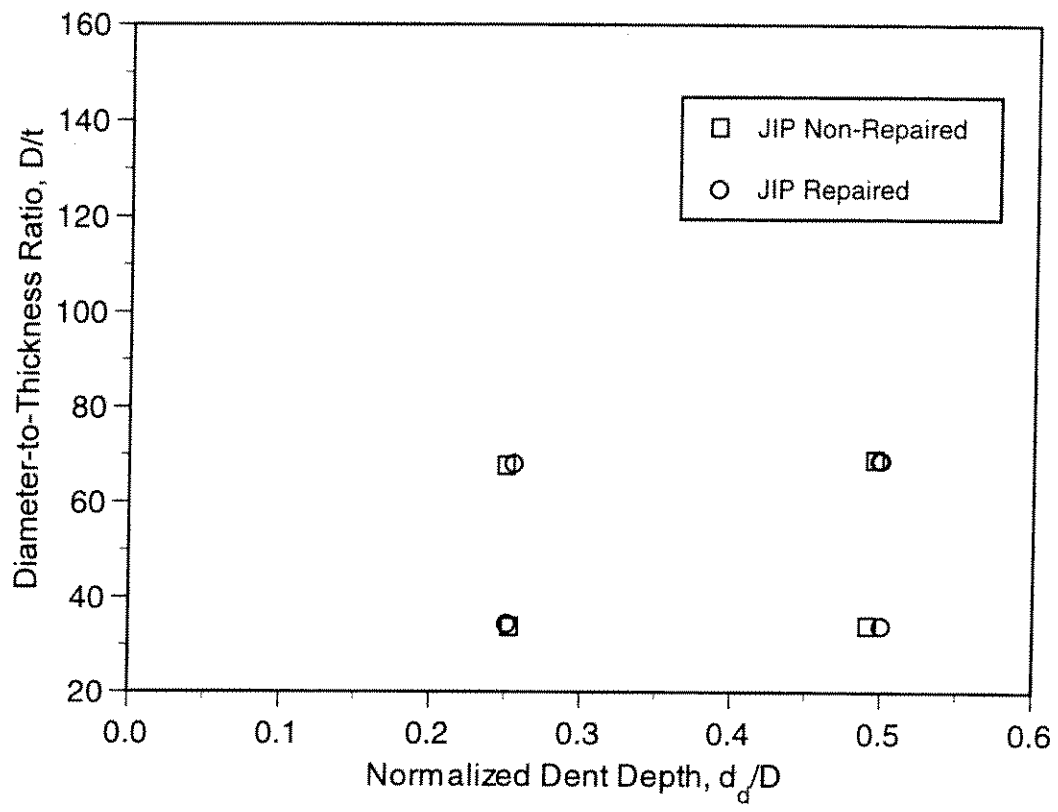
Figure 2.1 - Range of Measured Specimen  $D/t$  and  $d_d/D$  Ratios Tested in Current Program

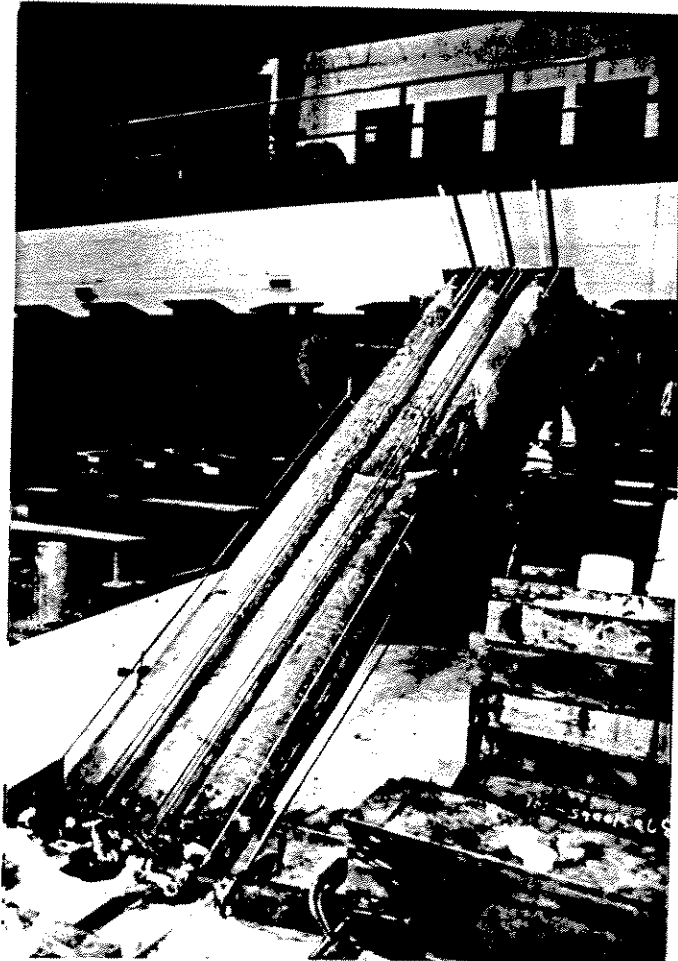
Figure 2.26 - Inclined Set-up for Internal Grouting of Repaired Specimens

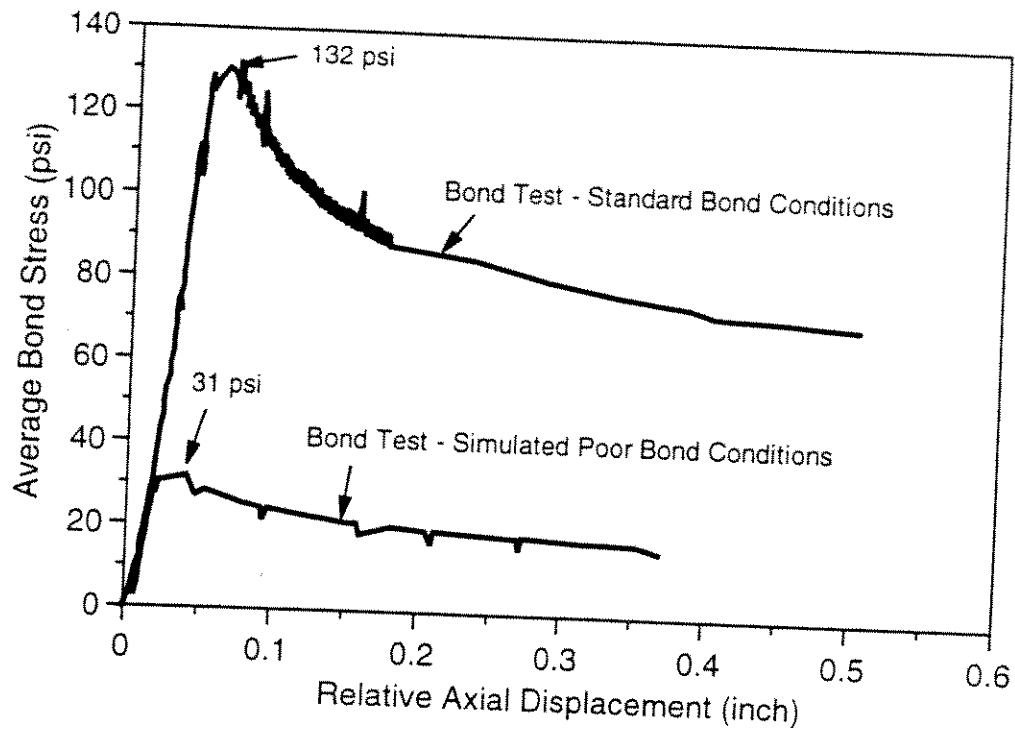
Figure 2.24 - Comparison of Average Shear Strength for Bond Test Specimens Simulating Standard and Poor Bond Conditions

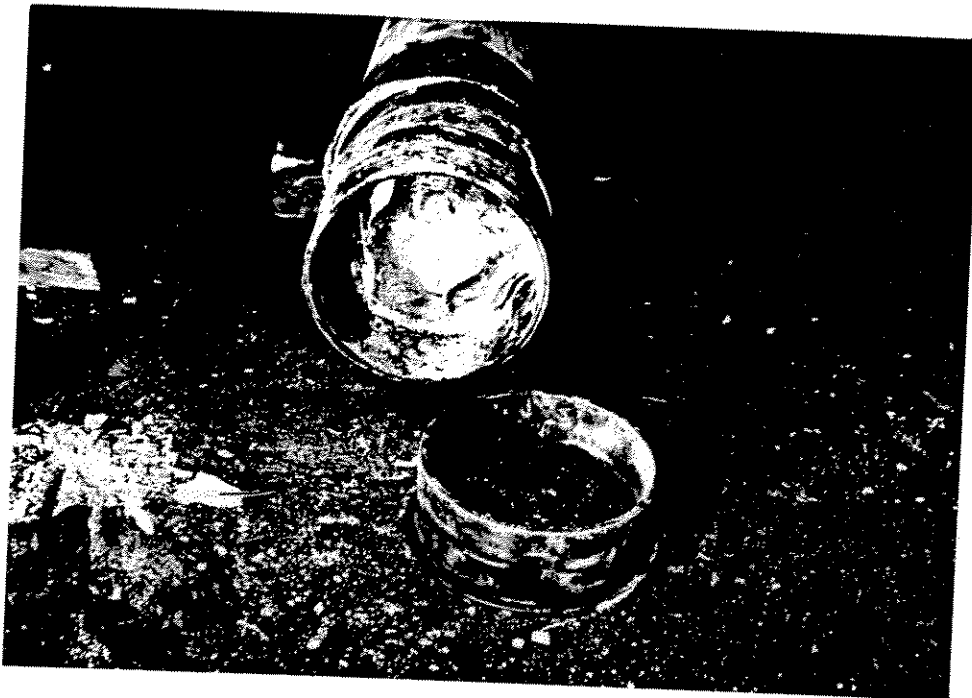
Figure 2.25 - Grout Void at Ends of the Repaired Specimens Ensuring Exclusive Application of Load into the Steel Tubular

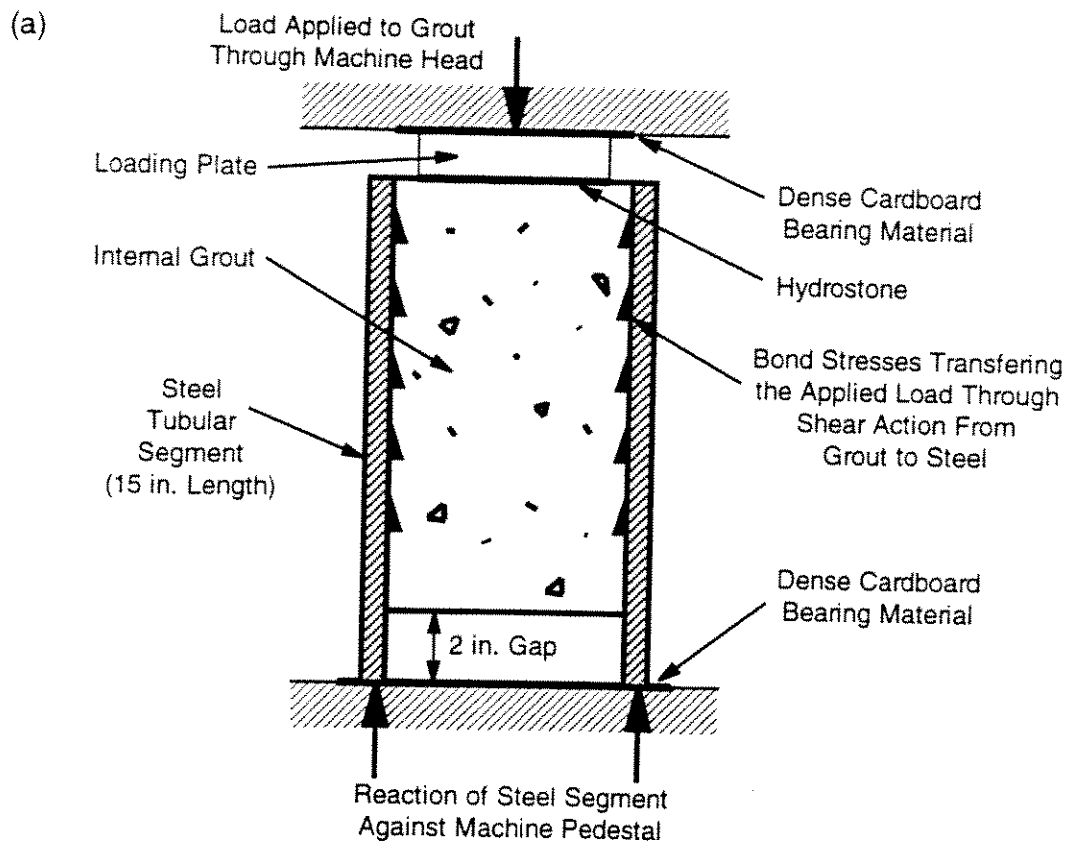
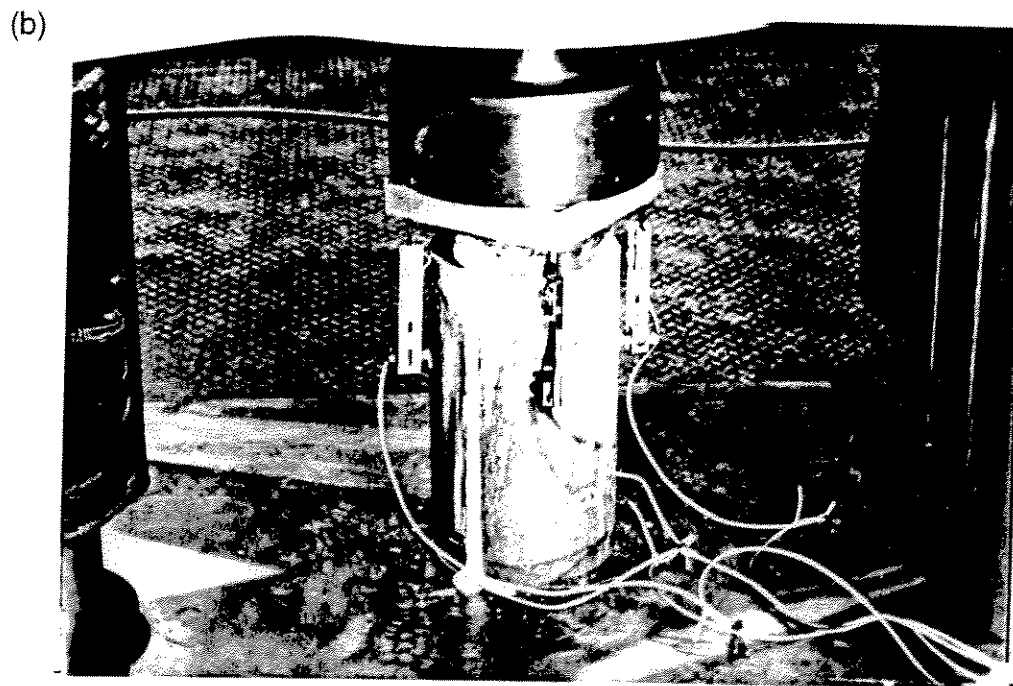
Figure 2.23 - (a) Schematic of General Set-up for Bond Specimen (Longitudinal Section Shown) and (b) Photograph of Bond Specimen in Universal Test Machine Prior to Loading

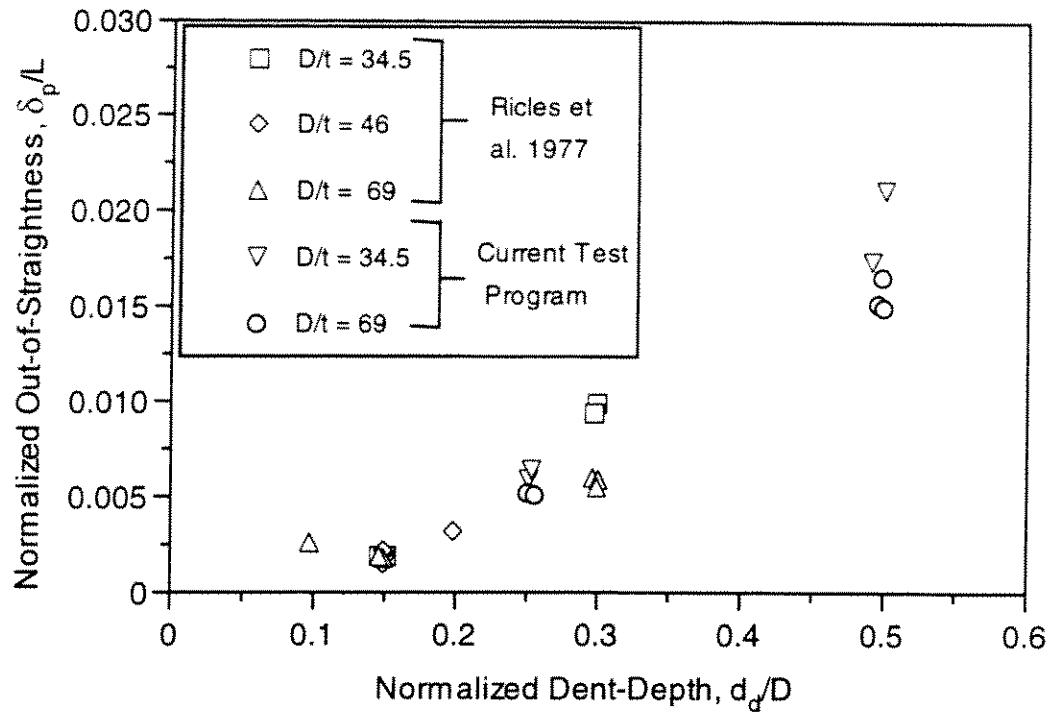
Figure 2.13 - Induced Global Out-of-Straightness After Infliction of Dent-Damage

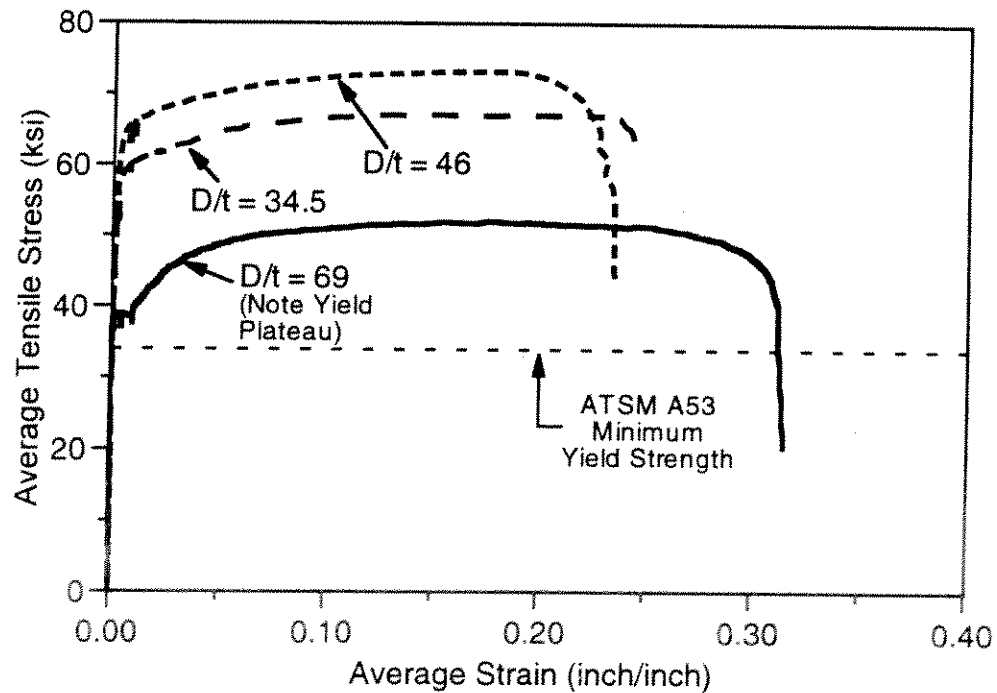
Figure 2.14 - Typical Stress-Strain Curves for Each D/t Prior to Annealing

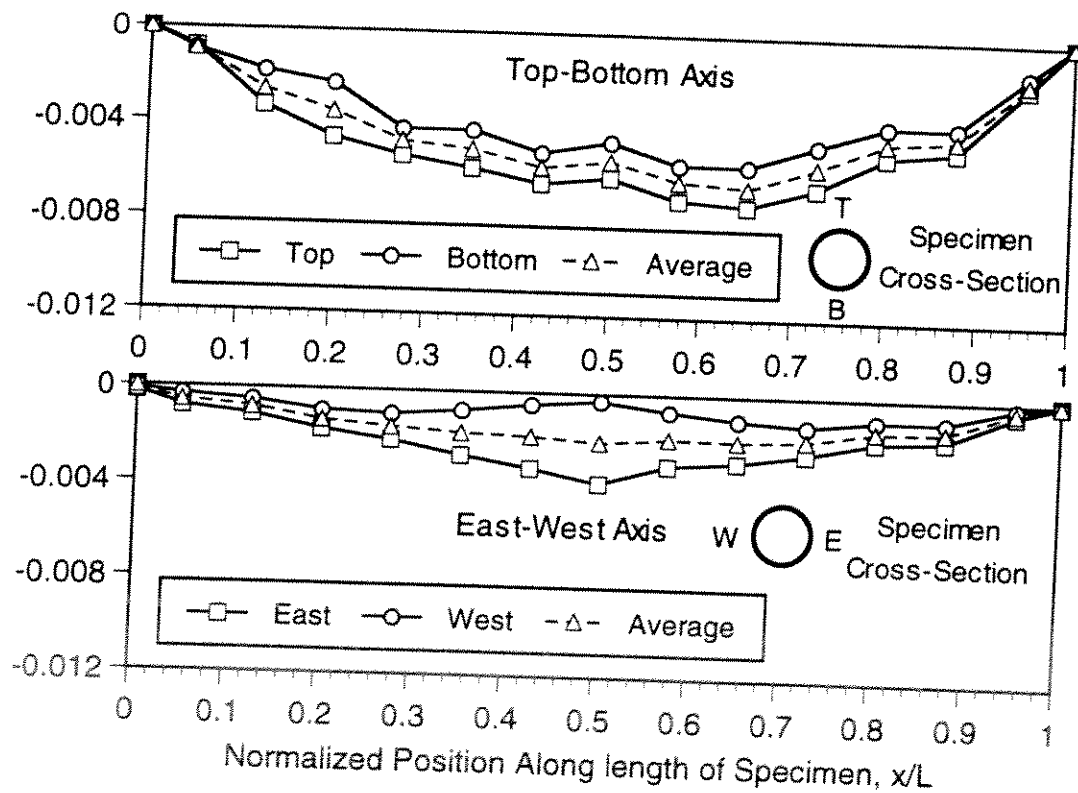
Figure 2.10 - Out-of-Straightness of Specimen A10 Measured After Infliction of Dent-Damage (Midspan Adjusted to Account for Dent-Depth)

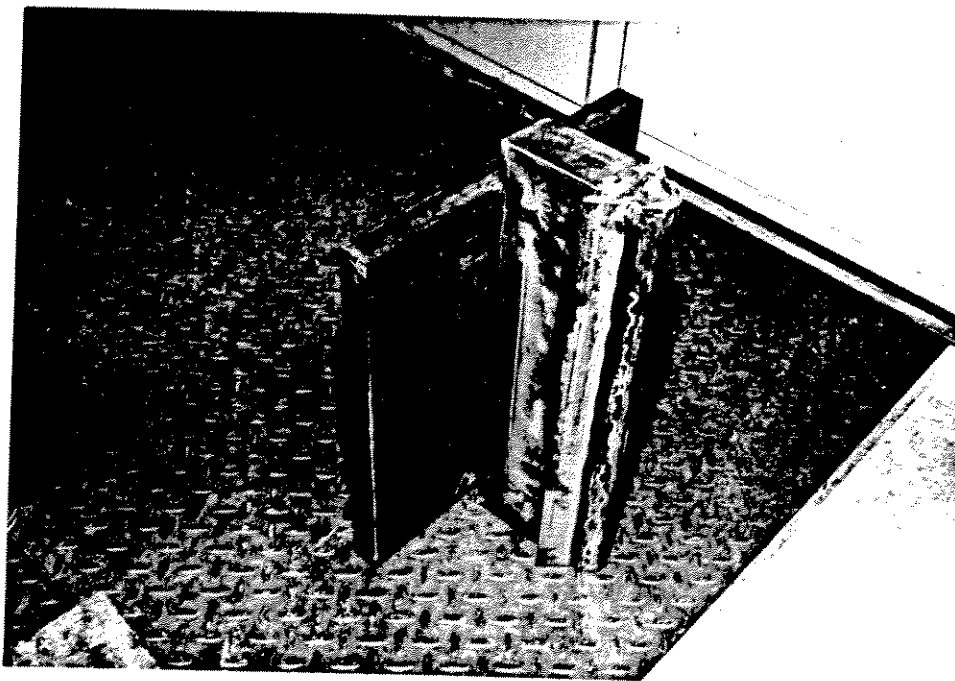
Figure 2.7 - Close-up View of Knife-edge Indentor Used to Inflict Dent-Damage

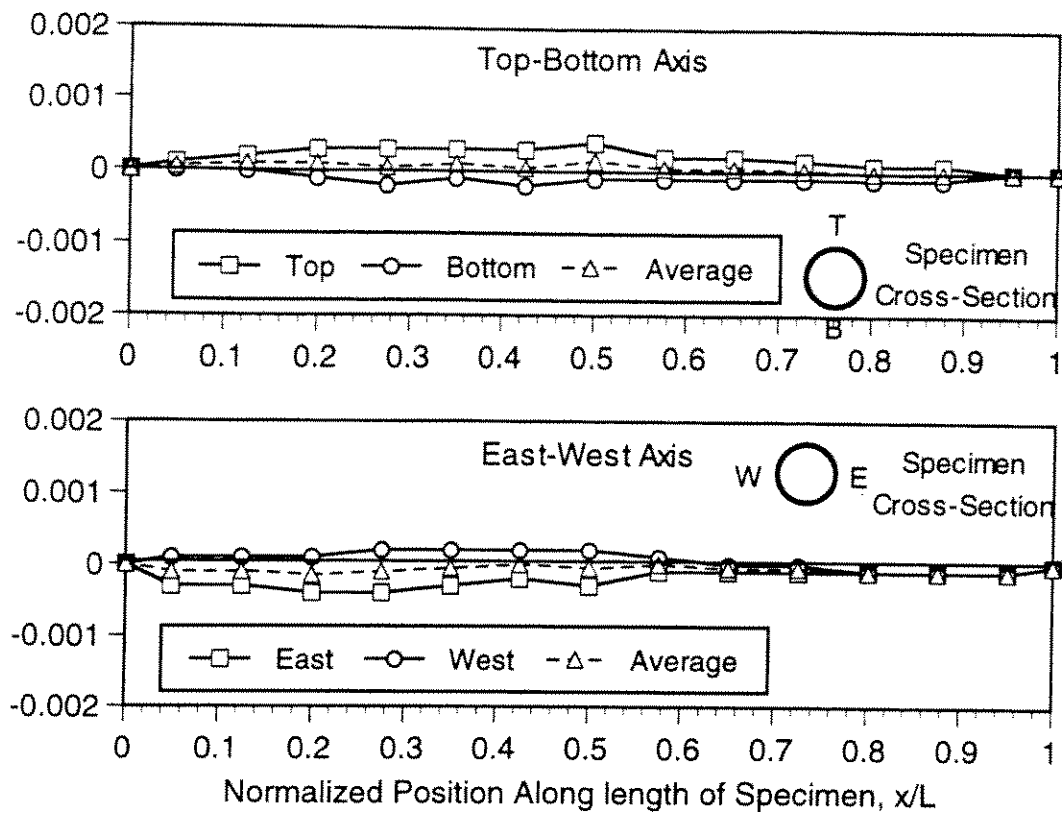
Figure 2.4 - Initial Out-of-Straightness of Specimen A10 Measured Prior to Infliction of Dent-Damage

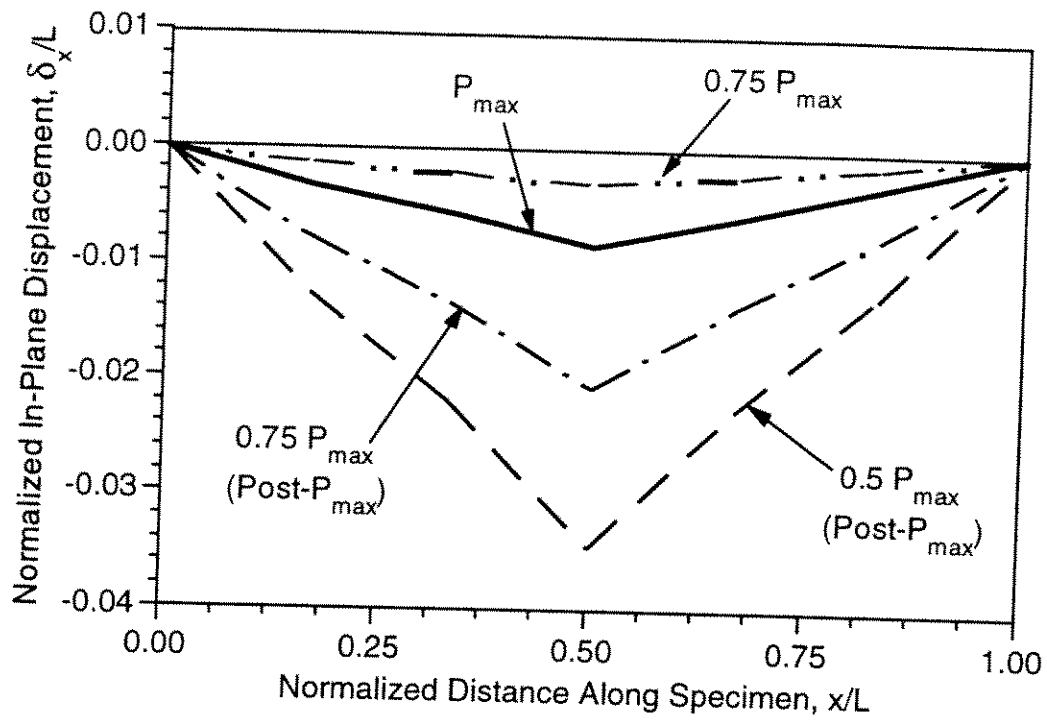
Figure 3.40 - Measured In-Plane Displacements of Specimen C12 at Various Stages of Loading

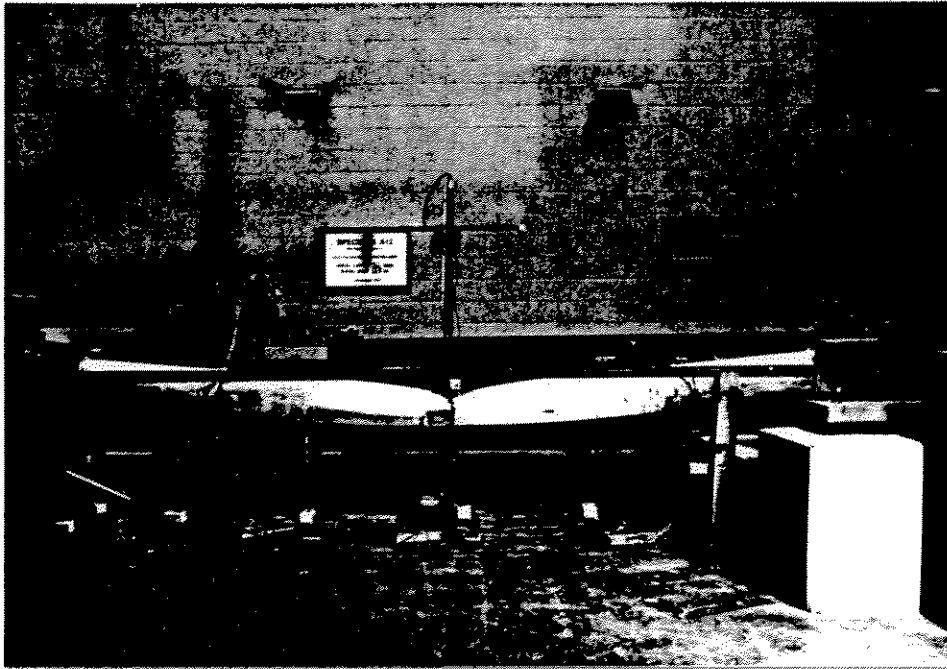
Figure 3.30 - Specimen A12 at Peak Axial Load

axial load is given in Figure 3.29, and shows the existence of large lateral defections prior to peak load. A photograph of Specimen A12 at peak load is shown in Figure 3.30, where the pronounced lateral deflection at midspan is visible.

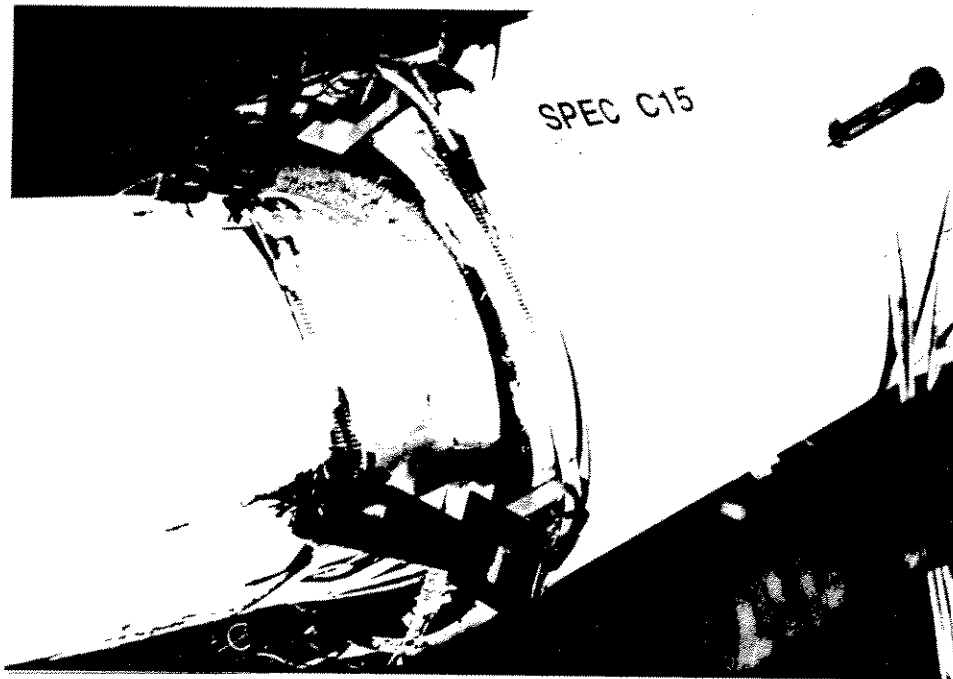
Figure 3.90 - Local Buckle in Tube at South End of Grouted Sleeve

At the peak applied axial load a local outward buckle developed in the specimen at the south edge of the sleeve where the prior yielding had occurred the top of the specimen resulted, and is shown photographed in Figure 3.90. This led to a deterioration of the axial load capacity with further imposed axial deformation. Continued imposed deformations caused the local buckle, which resembled an elephant's buckle, to attenuate around the circumference of the cross-section. In addition, the lateral displacements became greater, where a concentration of curvature developed at the buckled section, which was located at a distance of approximately  $0.30L$  from the south end of the specimen. This concentration of curvature is evident in the measured lateral displacement profile of the specimen (see Figure 3.86) as well as the photograph of the specimen shown in Figure 3.91. No significant slip was measured between the sleeve and tubular, however, the local buckling caused a shortening of the gage length of the slip gages. This phenomena is seen in Figure 3.92. Upon achieving an axial shortening of 4 inches, corresponding to  $0.022L$ , the test was terminated.

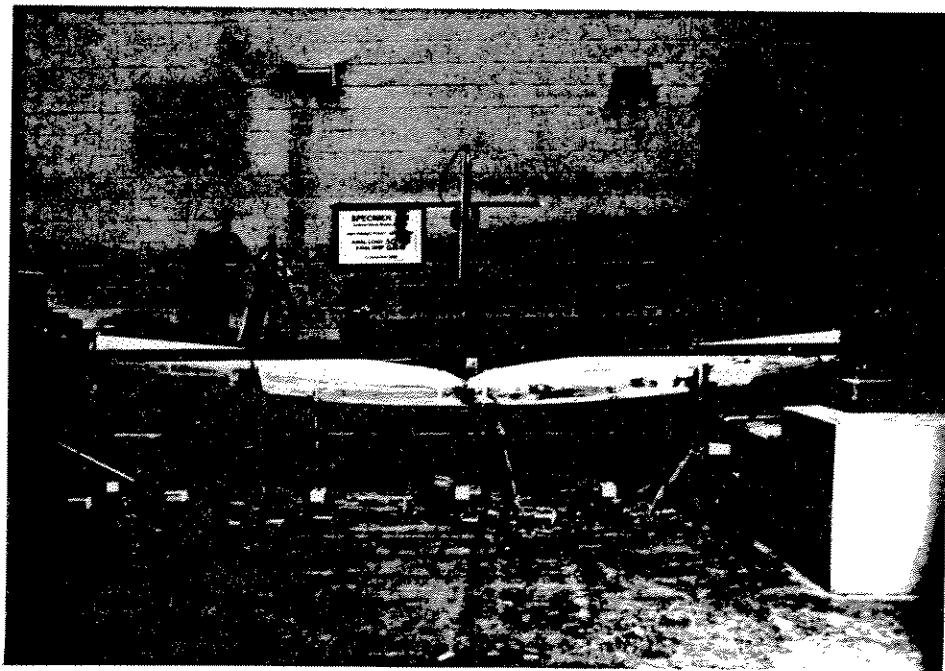
Figure 3.67 - Specimen A13 at Application of Maximum Axial Load

At the maximum load of 50 kips ( $P_u = 0.21 P_y$ ), the lateral deflection of the member at midspan was approximately equal to  $0.005L$ . Figure 3.67 shows a photograph of the specimen at ultimate load, where the lateral deflection of the specimen can be seen. Growth in dent-depth was insignificant, being arrested by the grout as shown in Figure 3.68. At peak load, the compressive strains developed in the dent saddle were approximately equal to the yield strain, as shown in Figure 3.69, indicating that plastification of the section was beginning to take place. The lateral displacement profile, shown in Figure 3.70, indicates that a concentration of curvature in the dented region had developed at peak load due to the plastification of the dented cross-section. Flaking of the applied white wash was not observed in Specimen A13, due in part to the lack of mill scale on the outer surface of the tubular. With continued axial shortening beyond maximum axial load the capacity of Specimen A13 gradually deteriorated, as shown in the load-displacement relationships (Figures 3.64 and 3.65). Photographs of the dented region and overall view of Specimen A13 at the end of the test are shown in Figures 3.71 and 3.72.

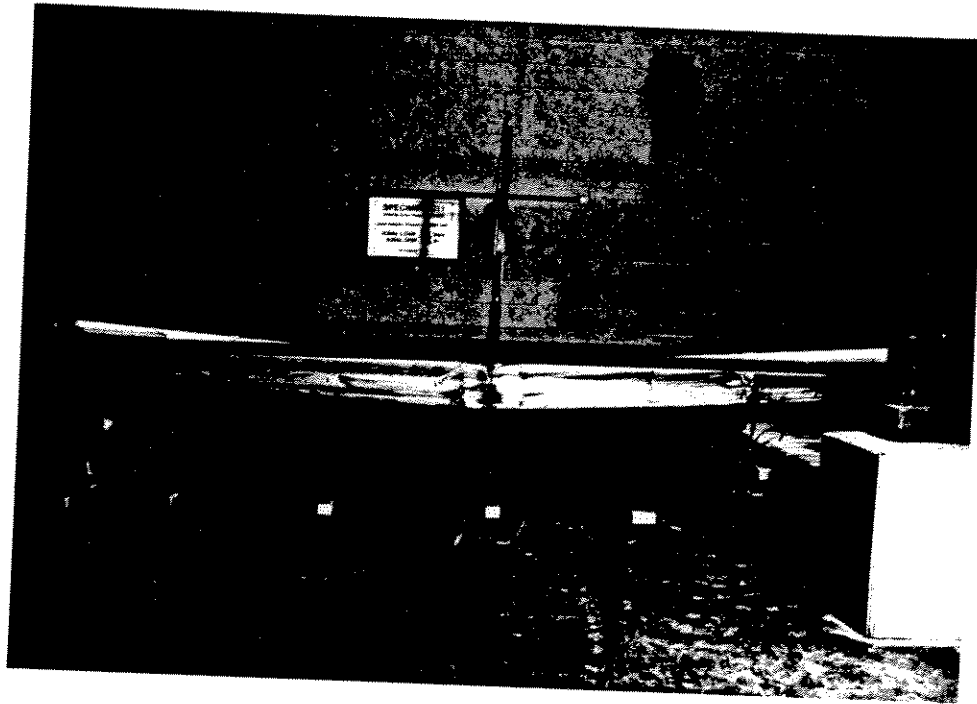
Figure 3.60 - Specimen C11 After Achieving Maximum Axial Load (  $\delta = 0.01L$  )

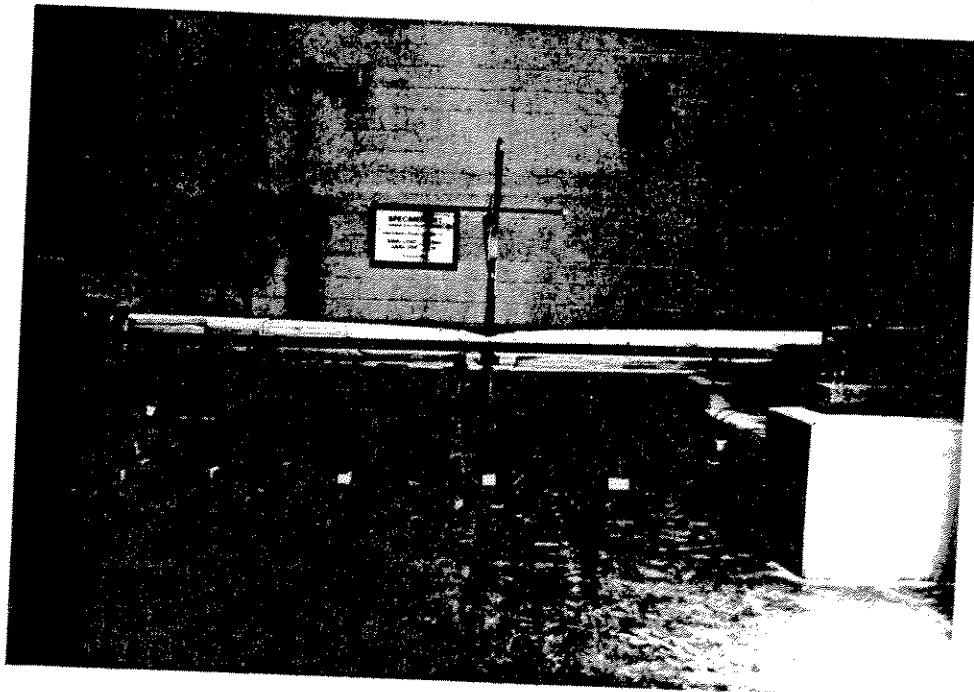
Figure 3.53 - Specimen C11 Prior to Testing

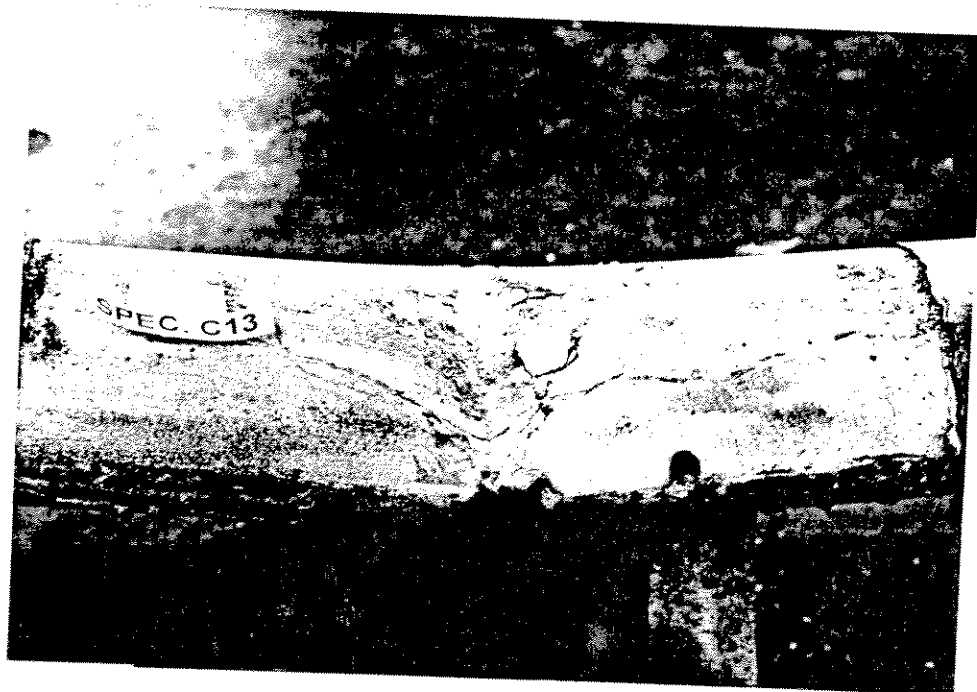
Figure 3.108 - Exposed Grout in Dented Zone of Specimen C13 After Completion of Testing

Following the completion of testing, the internal grout repaired specimens were cut open in the dent zone in order to expose the grout. This was accomplished by using a flame torch to burn through the wall thickness of the steel tube. The exposed grout of the specimens (Specimens A11, C11, A13 and C13) are shown in Figures 3.105 through 3.108. During the dissection the steel wall of each tube was found to be rather easily removed, indicating a weak radial bond existed between the steel tube and grout. In all cases, the exposed grout showed an area of intact grout that was directly beneath the dent saddle where the steel tube had remained in contact with the grout. Adjacent to this area, loose, cracked grout was found where the steel tube had locally buckled outwards.

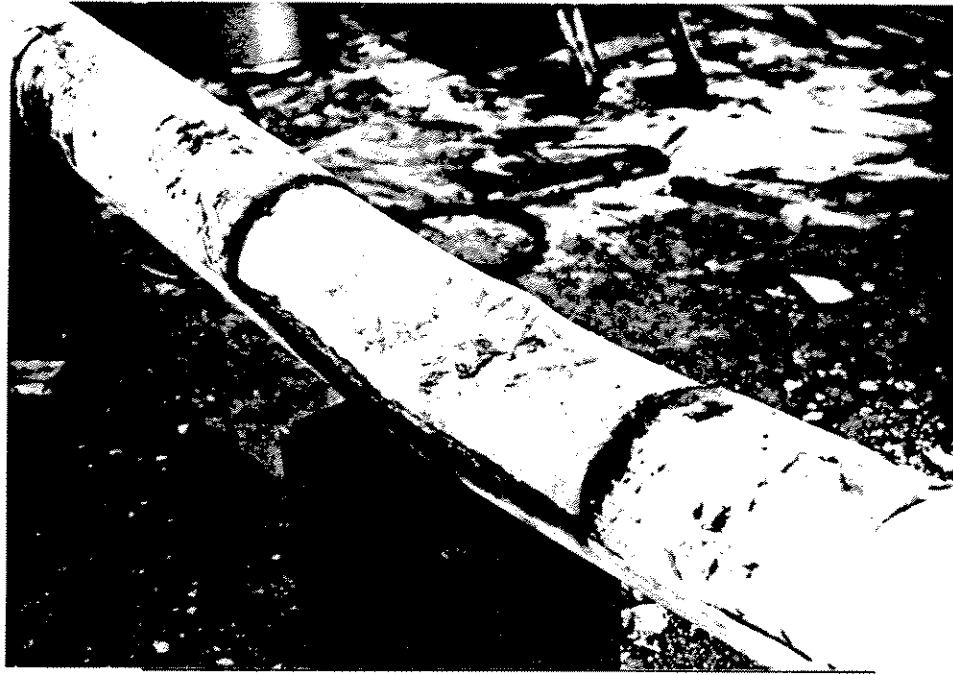
Figure 3.105 - Exposed Grout in Dented Zone of Specimen A11 After Completion of Testing

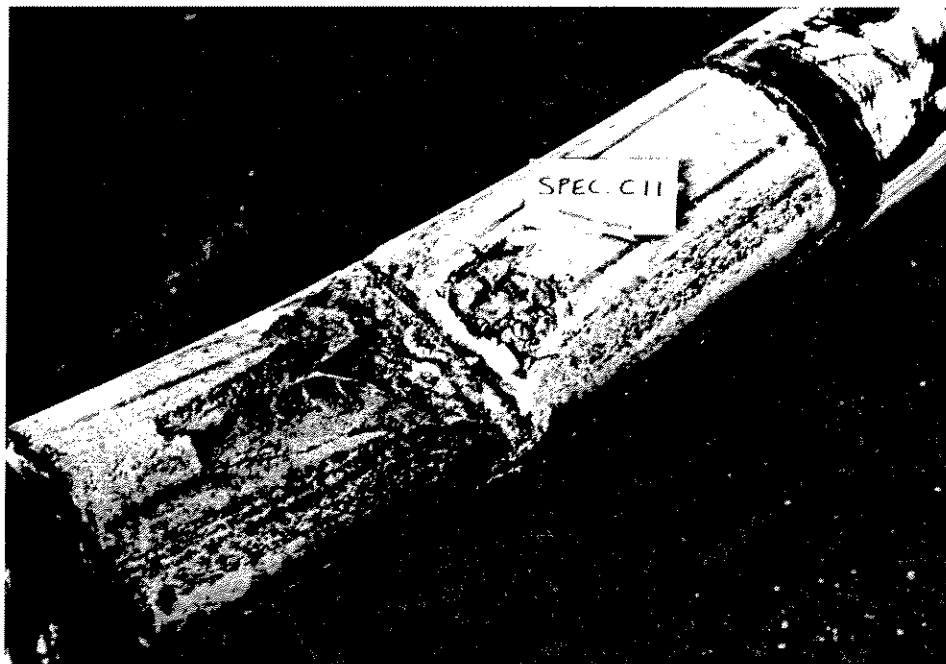
Figure 3.106 - Exposed Grout in Dented Zone of Specimen C11 After Completion of Testing

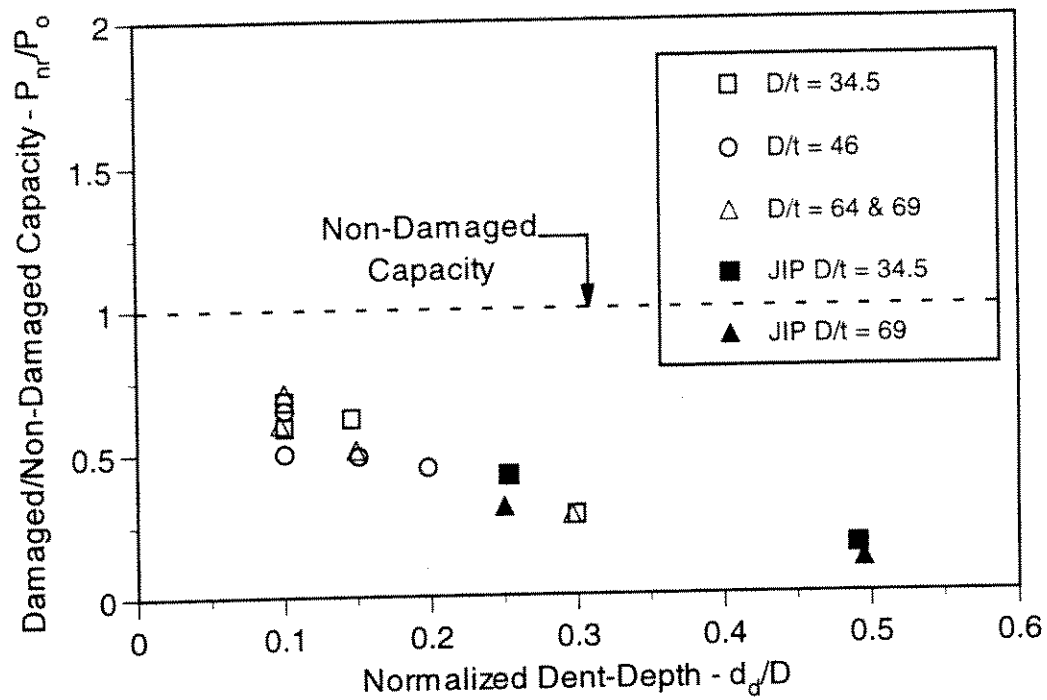
Figure 4.10- Effect of Dent-Damage on Specimen Ultimate Capacity (Previous Experimental Data from Ricles et al. [1992, 1997] Included)

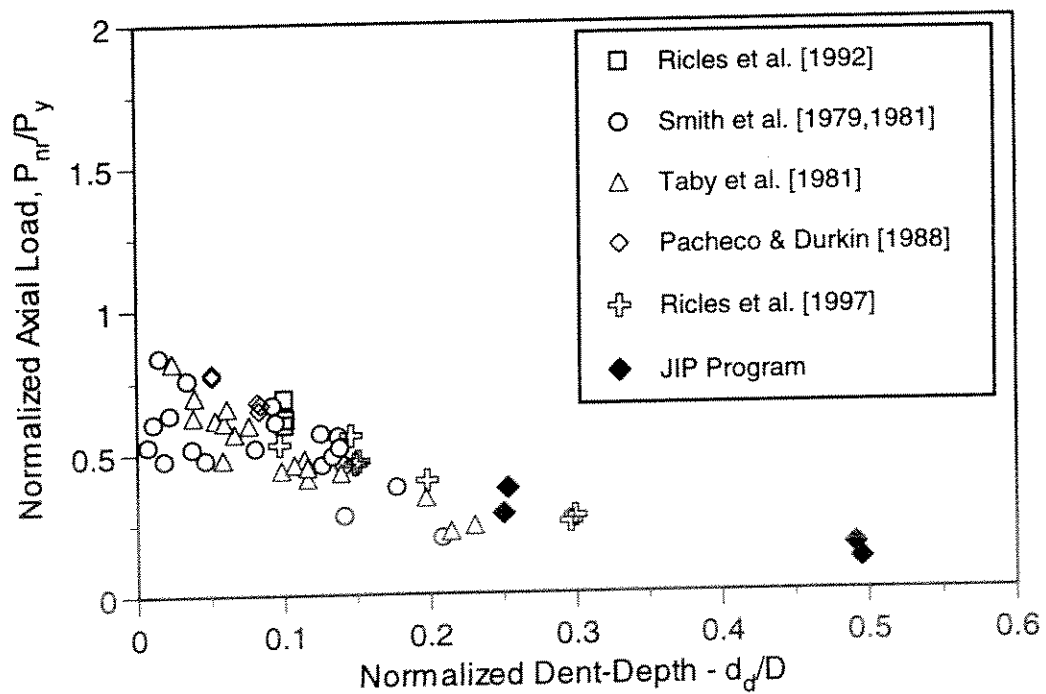
Figure 4.11 - Effect of Dent-Damage on Specimen Ultimate Axial Capacity

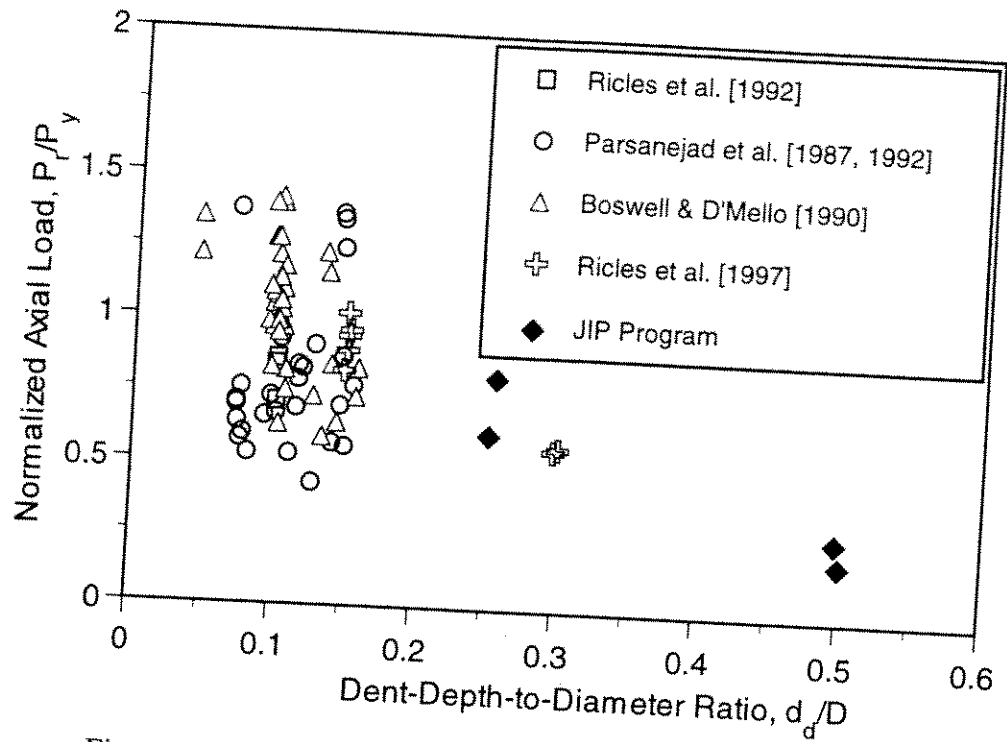
Figure 4.12 - Effect of Internal Grout Repair on Ultimate Axial Capacity

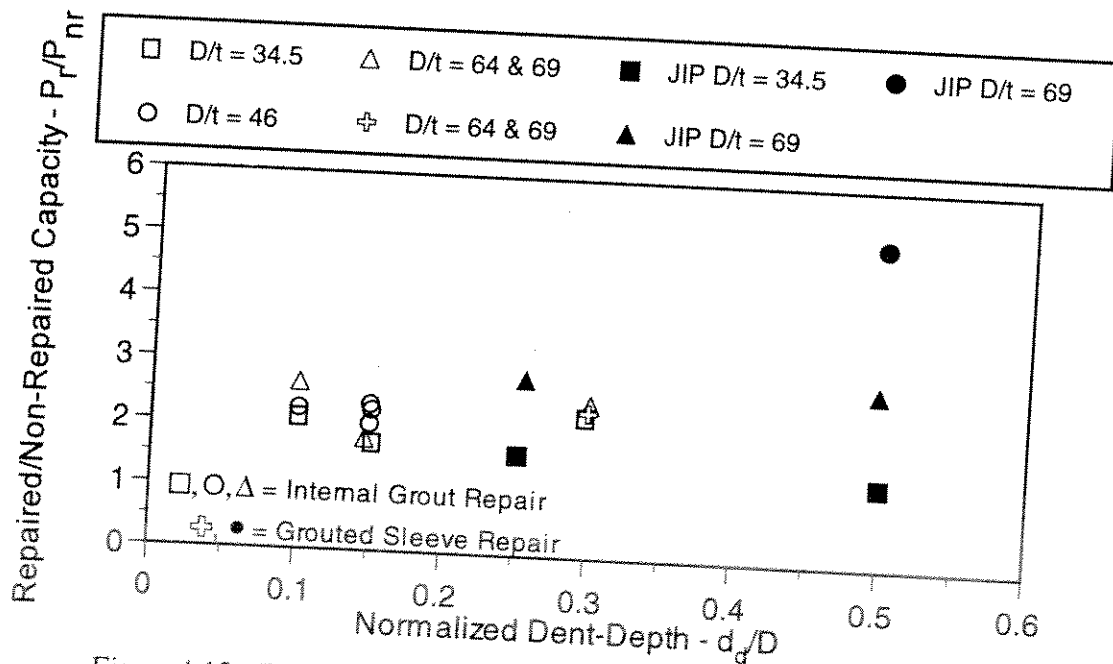
Figure 4.13 - Relative Increase in Dent-Damaged Axial Load Capacity After Grout Repair (Previous Experimental Data from Ricles et al. [1992, 1997] Included)

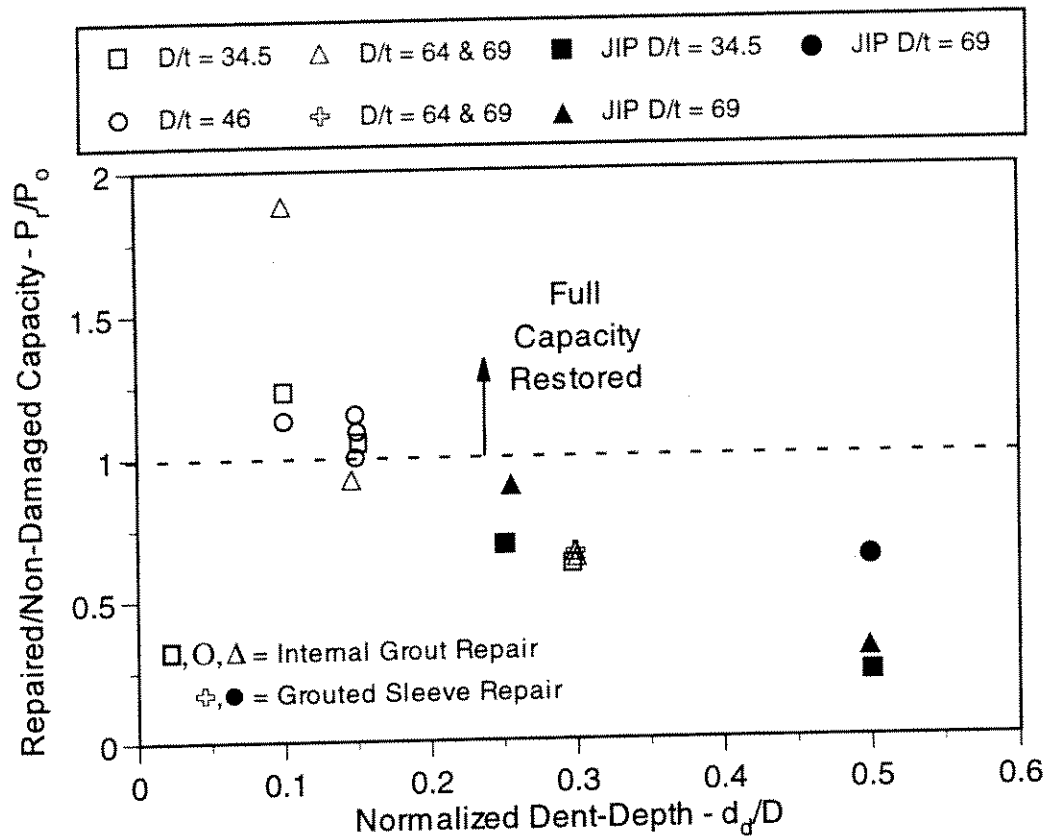
Figure 4.14 - Effectiveness of Axial Capacity Restoration by Grout Repair  
(Previous Experimental Data from Ricles et al. [1992, 1997] Included)

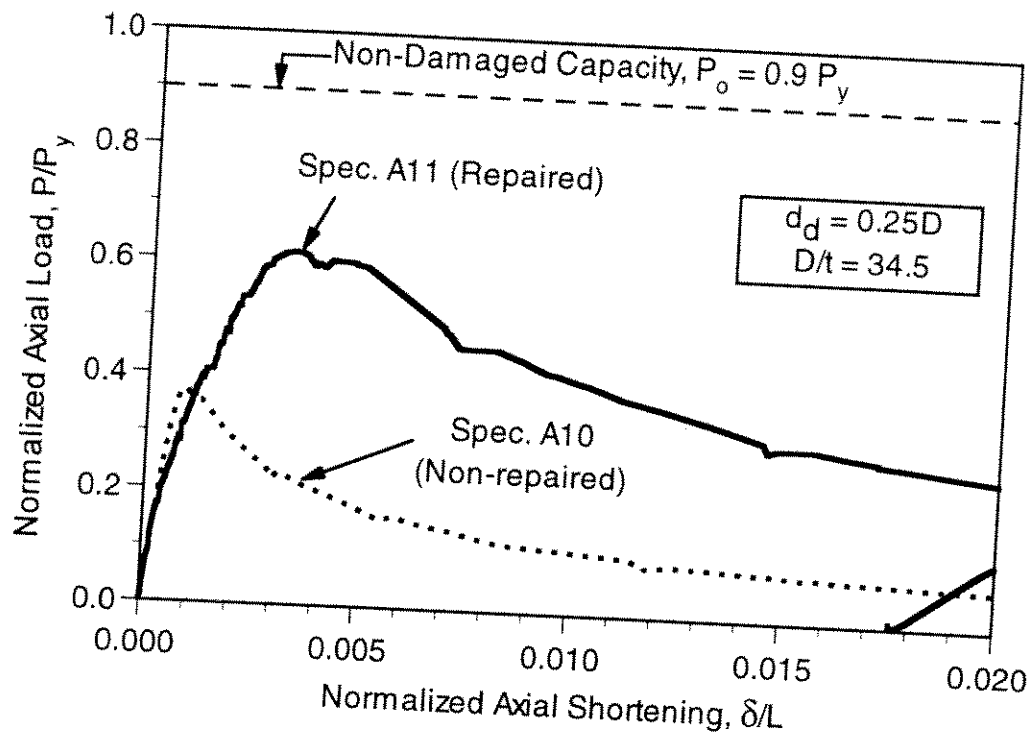
Figure 4.15 - Comparison of Axial Load-Shortening Response for Internal Grout Repaired and Non-repaired Specimens,  $d_d = 0.25D$  &  $D/t = 34.5$

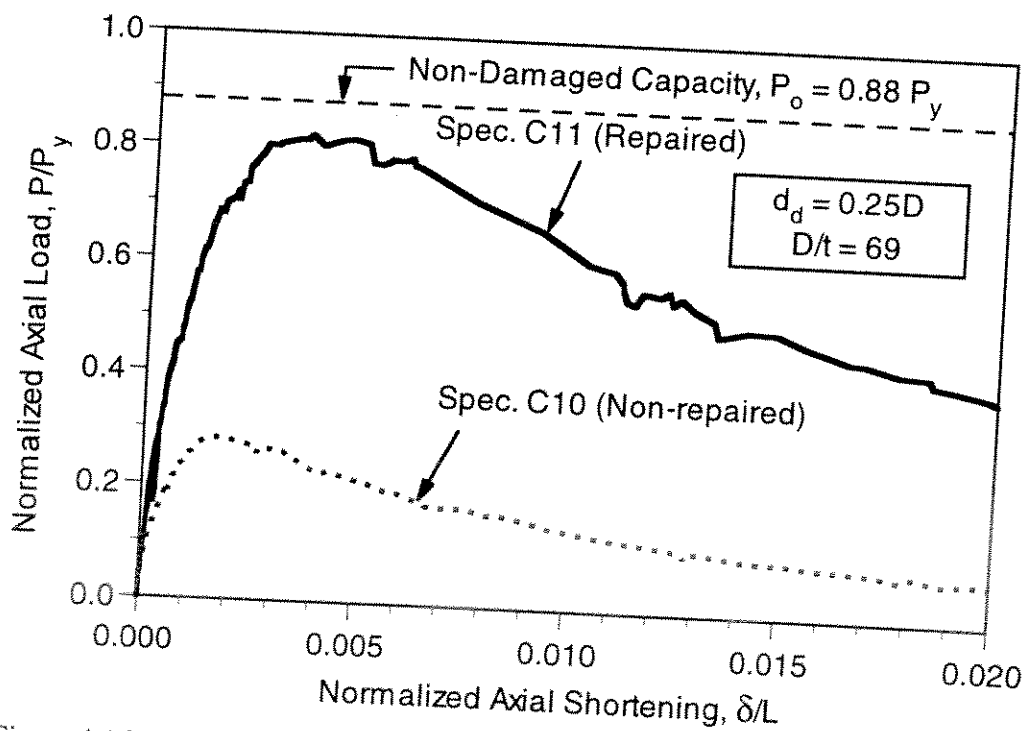
Figure 4.16 - Comparison of Axial Load-Shortening Response for Internal Grout Repaired and Non-repaired Specimens,  $d_d = 0.25D$  &  $D/t = 69$

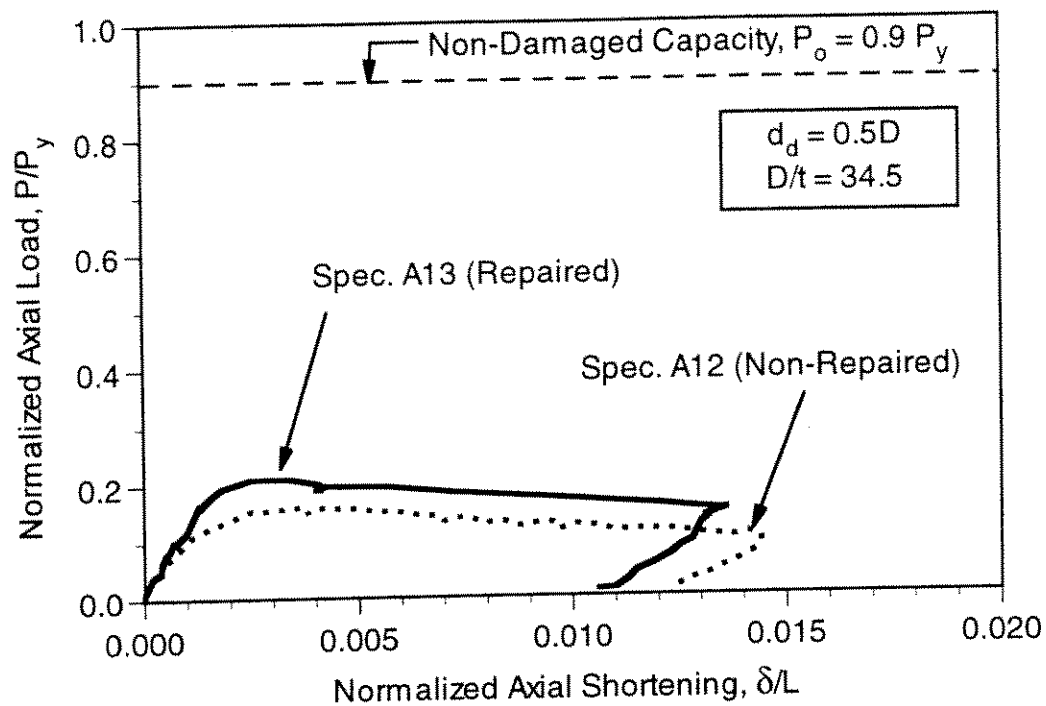
Figure 4.17 - Comparison of Axial Load-Shortening Response for Internal Grout Repaired and Non-repaired Specimens,  $d_d = 0.5D$  &  $D/t = 34.5$

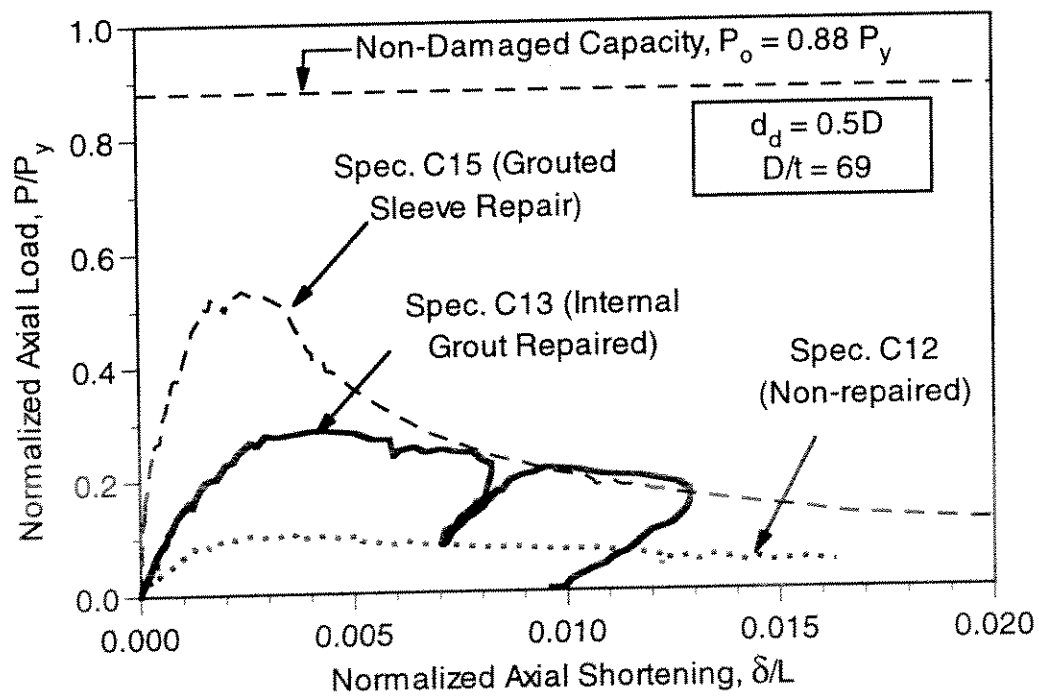
Figure 4.18 - Comparison of Axial Load-Shortening Response for Internal Grout Repaired and Non-repaired Specimens,  $d_d = 0.5D$  &  $D/t = 69$
